Forward Bulkhead replacement Wavelength 24

Project description: Replace forward bulkhead in Wavelength 24. The old bulkhead was tabbed around the entire perimeter, even the bottom. With no limber hole or opening, any water forward of the bulkhead could not drain. The bulkhead did not appear to be protected or encapsulated in any way. Over time, the bottom several inches of the bulkhead had deteriorated due to water intrusion.

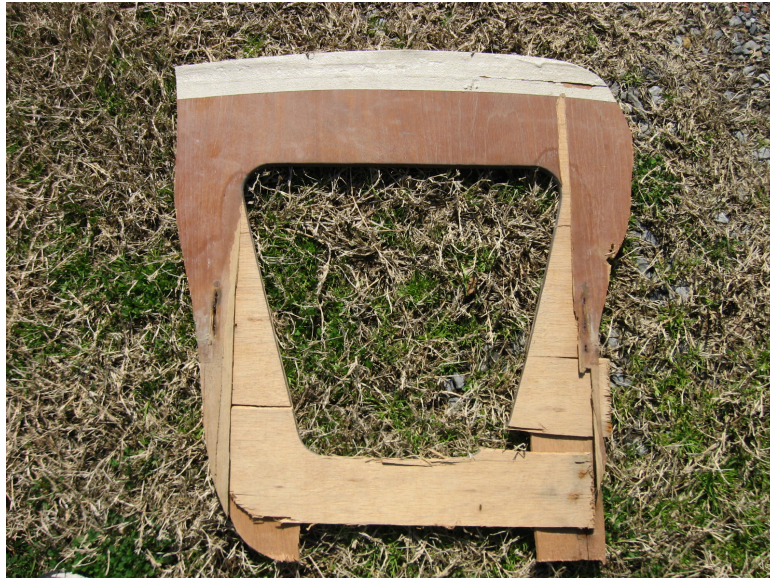
Project demolition and preparation: First, removal of the old bulkhead was required. In order to save the original pattern for the anchor locker access, the center of the bulkhead was cut out with a jigsaw. The deteriorated bottom portion fell apart during removal but enough pieces were salvaged to reconstruct the pattern.

Figure 2 Center of old bulkhead cut out for pattern for anchor locker access

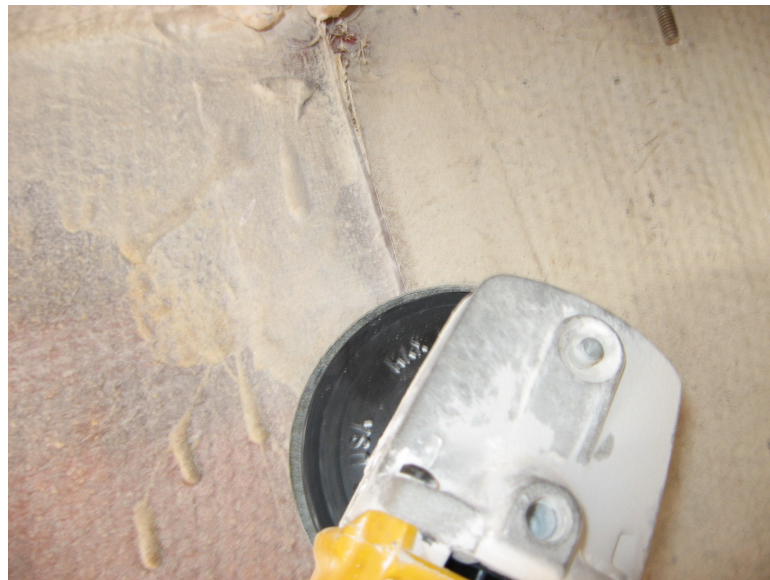
Figure 3 Side grinder with 60 grit for removal of old tabbing

Next, the residual tabbing was ground out to provide a smooth area for the new tabbing. If adequately bonded to the hull, the periphery of the tabbing may be left and the new tabbing bonded to it. While grinding, the peripheral tabbing was carefully inspected for “unhealthy” bonding. Weak bonding can be recognized by opaque areas in the glass. Any unhealthy spots were ground to the hull to expose healthy glass to which the new tabbing will bond.

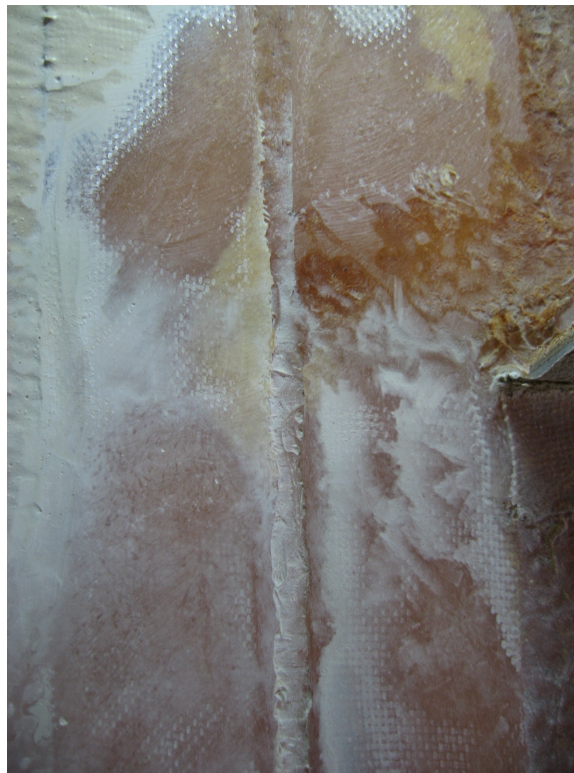
Figure 4 All tabbing removed and surface smoothed

In Figure 4, note the whitish opaque spot at right center where the cloth weave can be clearly seen. This glass was not properly laid in and is not adequately bonded to the understructure. This area was just under the V-berth shelf. Note the translucent yellow/orange area at the top of the picture. This is healthy glass to which new fiberglass can be adequately bonded.

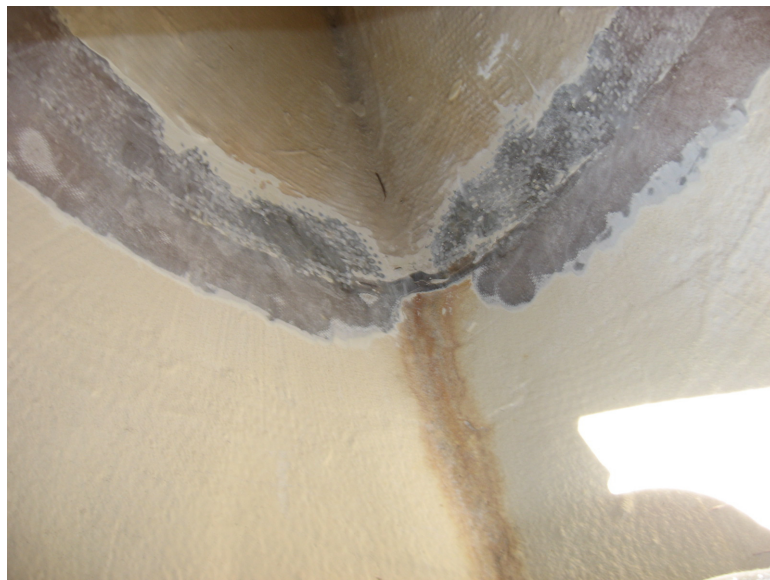
Figure 5 Tabbing ground out and area smoothed

The bottom of the hull's V was ground out to allow free drainage from forward. Note that the old bulkhead and tabbing completely blocked any drainage.

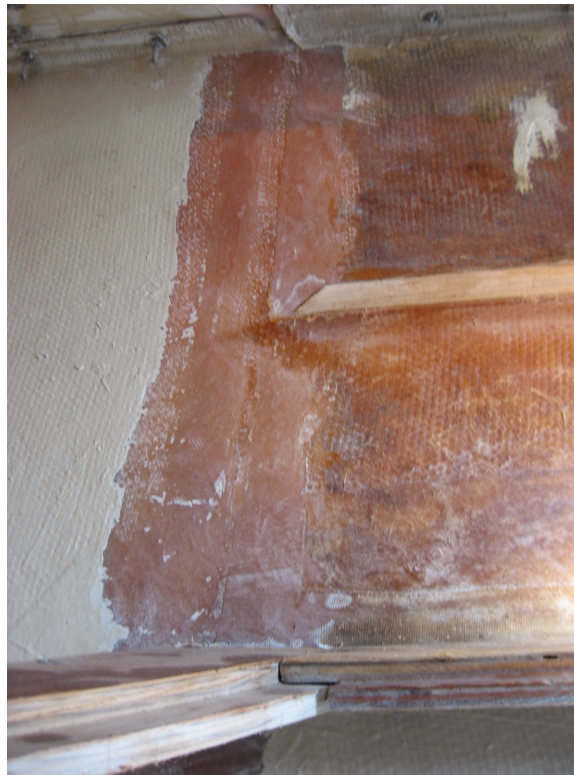
Figure 6 Tabbing on shelf left intact but cut back from bulkhead

The old V-berth shelves were tabbed from the top. Their deteriorated condition allowed the wood to simply be peeled from the bottom of the tabbing. The plan is to place the new shelves on top of the old tabbing and tab from the top.

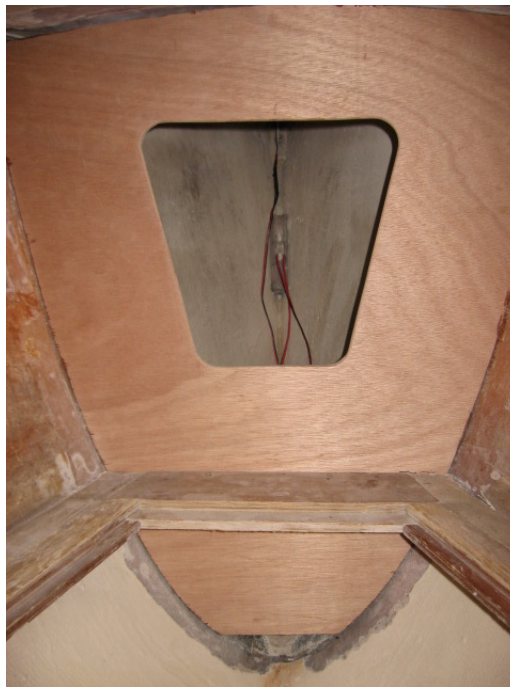
Figure 12 Bulkhead dry fitted

Bulkhead installation: The new bulkhead was dry fitted. Some additional shaping was required to make it fit closely. The final shaping was done with a side grinder with a 60 grit sanding disc.

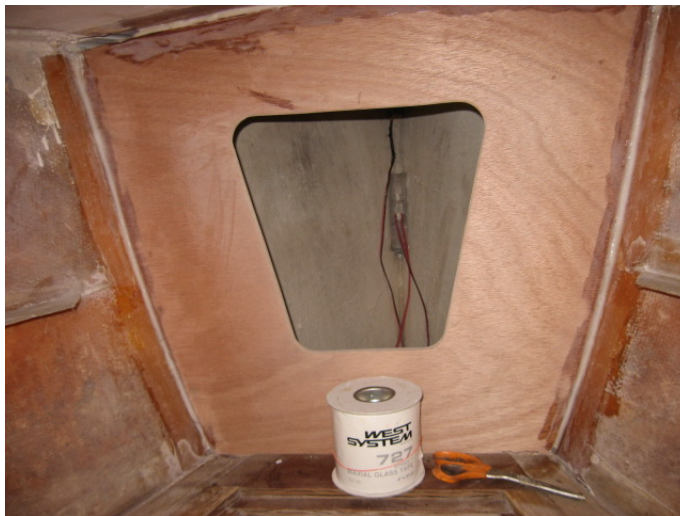
Figure 16 Fillet finished. Ready to apply tabbing

In order to eliminate a stress line on the hull, a fillet should be created at the bulkhead/hull joint. Pictured above are materials with which a fillet can be made. The epoxy resin and hardener are first thoroughly then West System 406 colloidal silica is added until the desired consistency is reached. The epoxy should be a bit stiffer than mayonnaise.

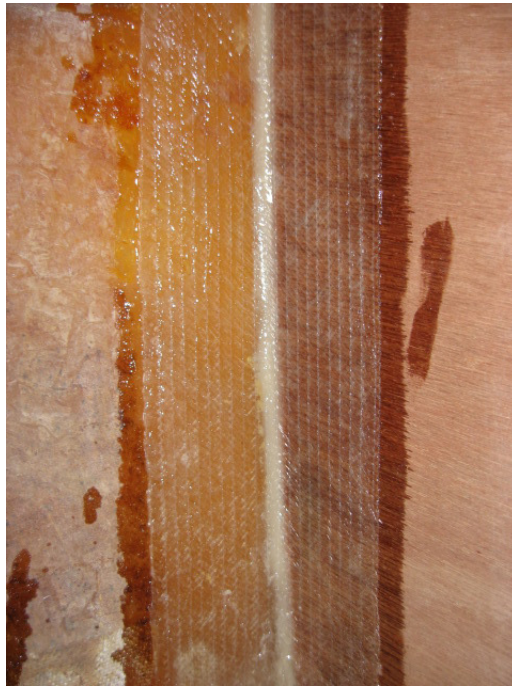
Figure 20 Close up of finished filleted tabbing

Close up of the finished tabbing. The one whitish spot at the bottom left is actually a ball of loose glass, not air bubbles.

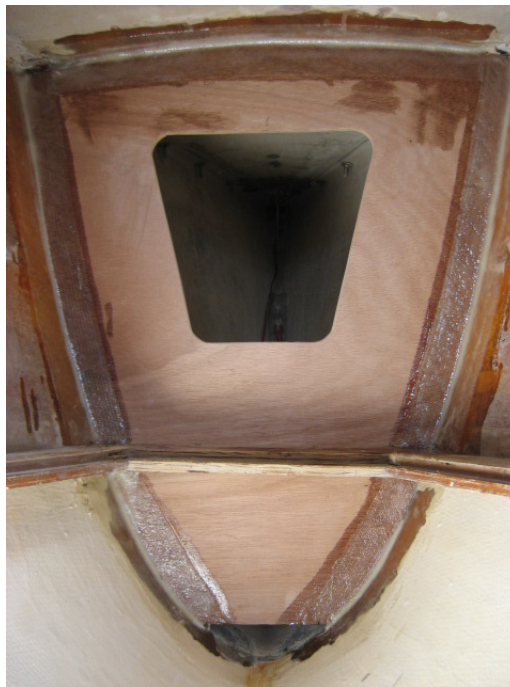
Figure 21 Bulkhead installed and tabbed

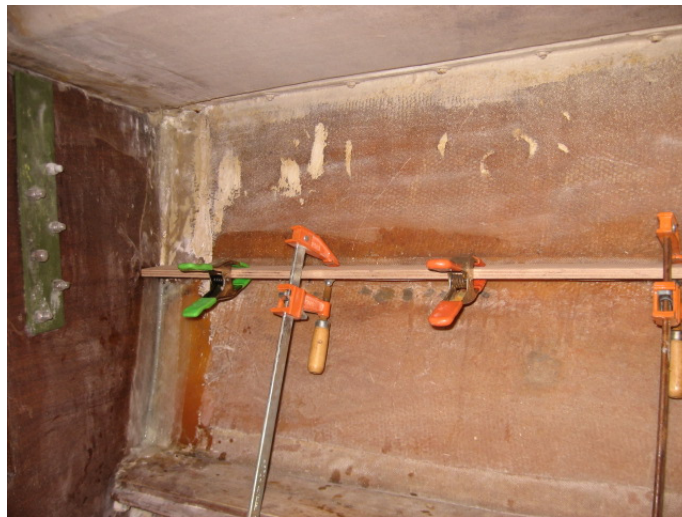
Figure 26 New shelf clamped onto old tabbing

Shelf installation: The new shelves were glued on top of the old tabbing with 3M Fast Cure 5200.

Here's a very technical issue. The shelves weren't deemed as structural as the bulkhead so less preparation was required. Above the shelves was a short strip of the old tabbing with the roving of inside of the hull above. Roving is fairly rough. If the shelves were structural and a robust bond required, the roving should be smoothed. Grinding the roving would remove strength from the hull. A smoothing coat such as thickened epoxy could be applied with a smooth edge spreader prior to tabbing.

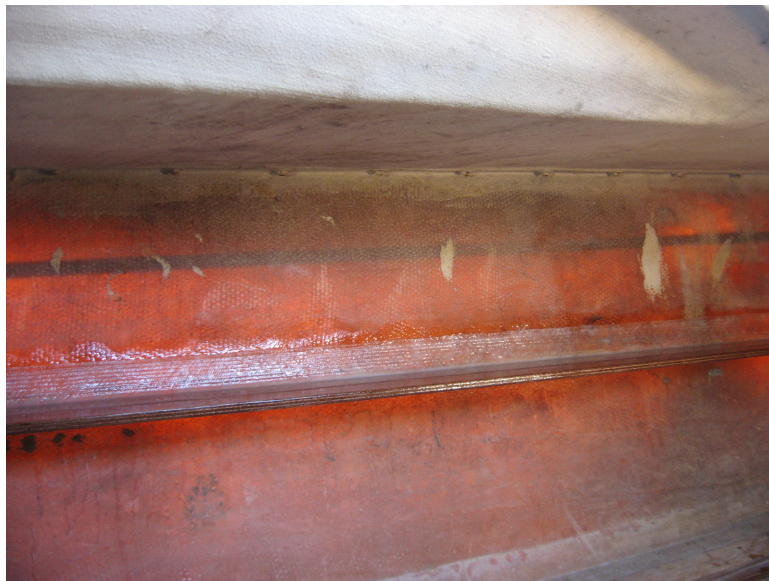
Figure 27 Shelf tabbing complete

Here the biaxial tape worked OK but had a few air bubbles due to the rougher contour of the roving on the inside of the hull. Cloth tape would have worked better than the stiffer biaxial cloth. The softer cloth would have conformed to the contouring of the roving better.

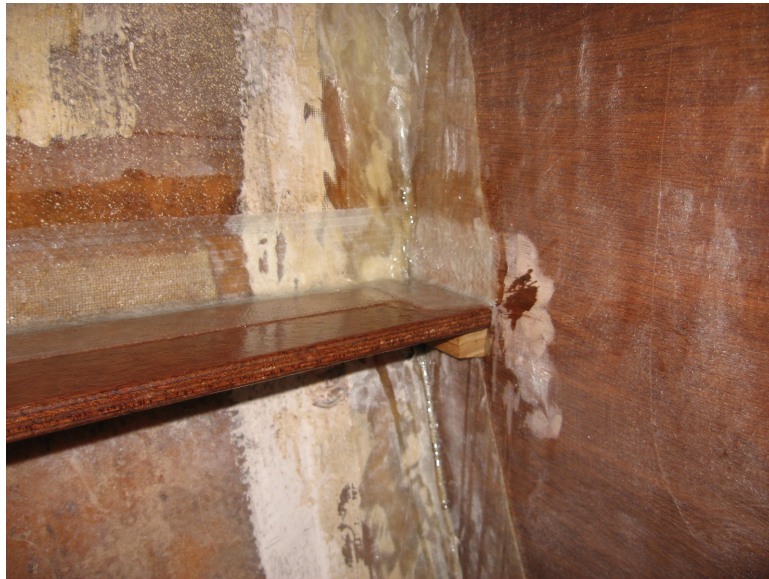
Figure 29 Shelf cleats and end tabbing

Finally, the shelf needs to be tabbed to the bulkheads. I added cleats for additional support from below. The cleats were glued in with West System G-Flex thickened epoxy. This will allow for a minor amount of flex, but it was handy and easy. The thickened epoxy will adhere nicely to the rough tabbing. Small design mistake. Should have cut the blocks at a 45 degree angle for aesthetics.
