## Idler Plate on a 1990's C&C 34/36

**If you are experiencing play in the steering wheel, it may mean the idler plate is failing.** Check your steering wheel for play and look under the pedestal for rust.

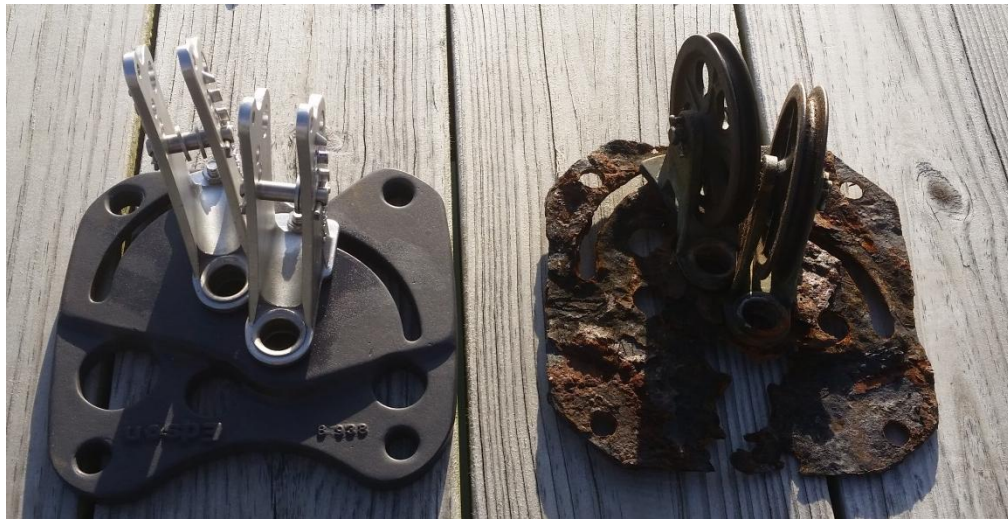
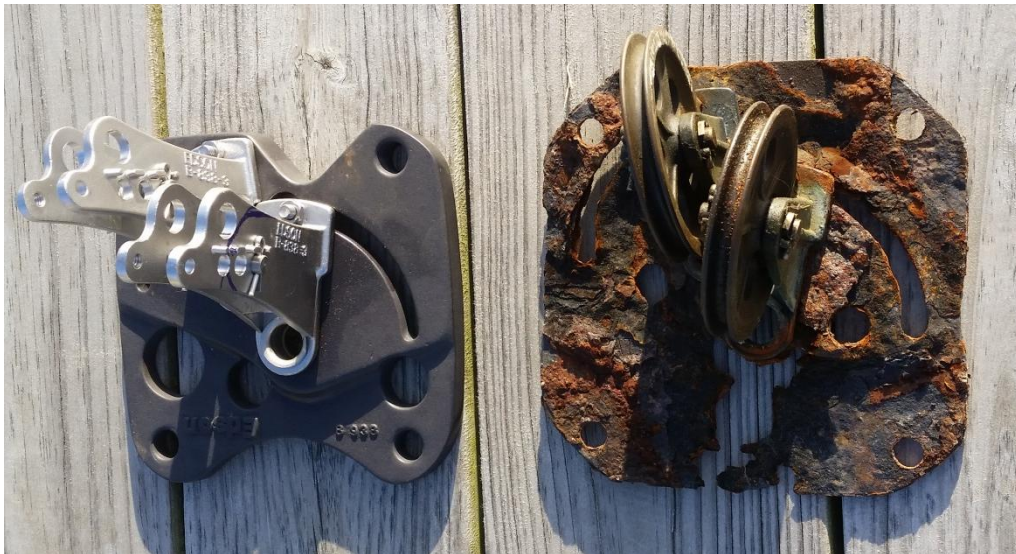
Here are some pics showing the new plate compared to the old one.

The original Edson plate was made from mild steel. It was cut and pressed into shape and painted black and is no longer made. The new Edson plate has a thick cast aluminum base with stainless sheave towers that are too long to fit our boats and have to be cut down to fit into the well under the pedestal. Using the lowest hole in the tower, I found I needed to lower the quadrant on the rudder shaft about 1/2". My old sheave towers are bronze and I wanted to reuse them but they are riveted onto the old plate. I contacted Edson several times but they never offered me good options. Bronze would make a better choice for something so important.

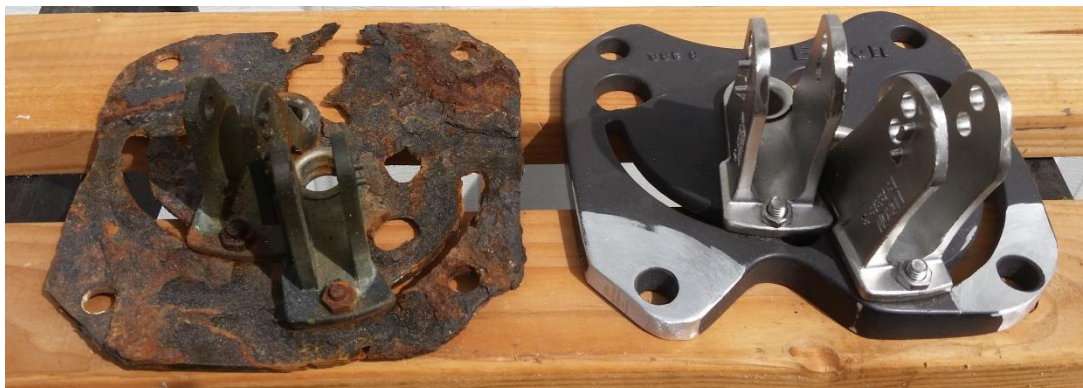
The new plate after modification

In the beginning, I thought I could grind the aluminum base or the fiberglass well, down enough to fit flush, but adding a trim ring between the pedestal and cockpit floor, made more sense. I was afraid to reduce the thickness and strength of fiberglass in the well. In the end I made a trim ring of 3/8" expanded PVC sheet. It can be found in 2015 at lumber yards for \$75 for a 4' x 8' sheet and they will cut it down so you can fit it inside a car. Great stuff to use on any outdoor project. It may be possible that 3/4" PVC or Starboard would reduce some grinding, not sure?

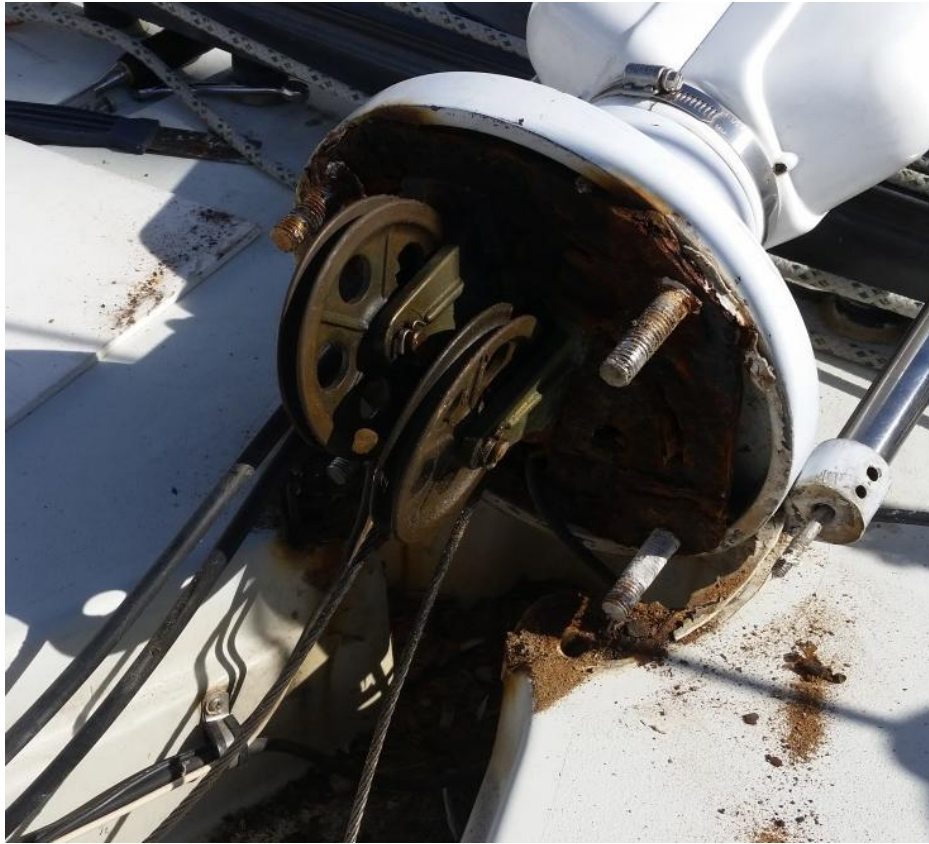
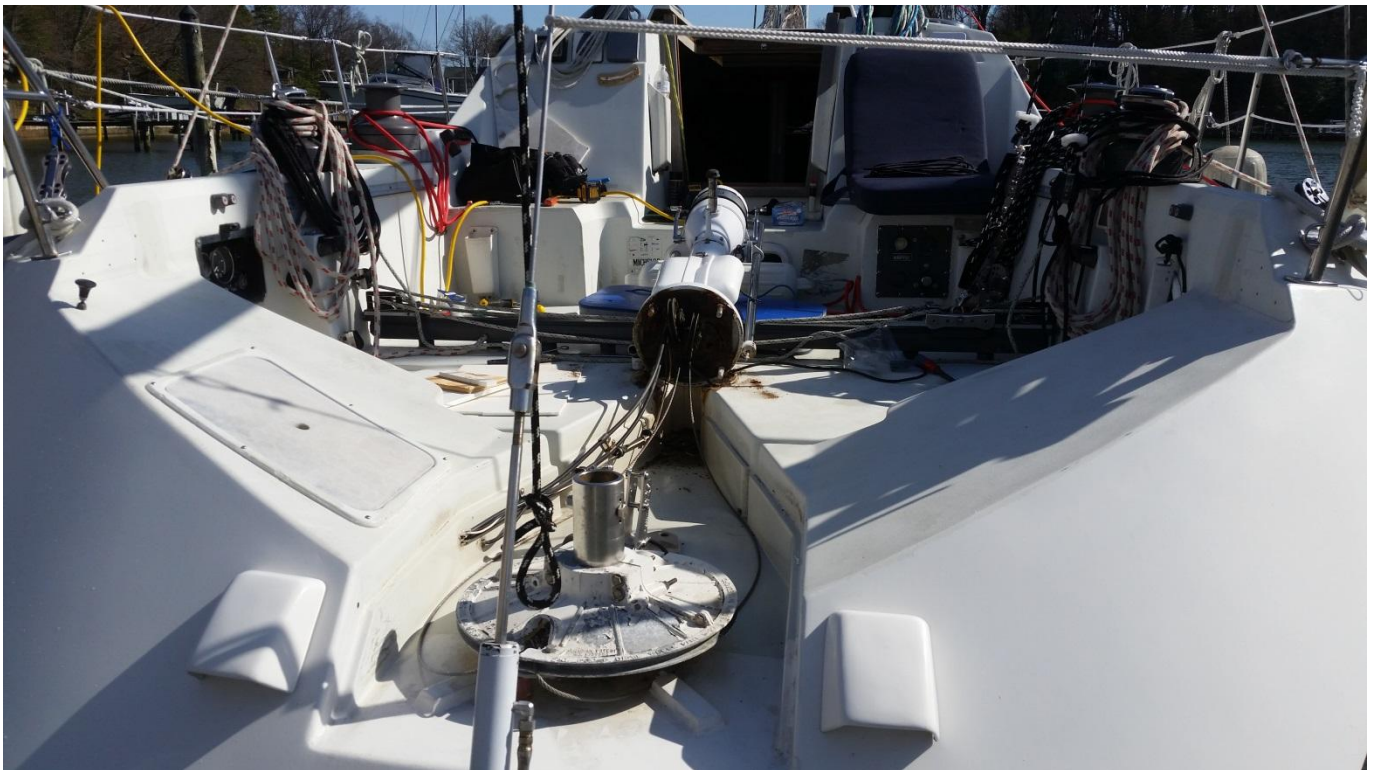
Brown Rust under an aluminum pedestal is a bad sign:

When the plate corrodes enough, the sheave towers under tension from the cables going to the quadrant and are pulled back. Tightening the cables can remove the slack but eventually an idler pulley will break loose or the cable will jump the sheave.

My steering system was trouble free for 12 years before I noticed about an inch of play in the wheel. Over the years, I had periodically oiled the cables and sheave axles but never needed to adjust the cables. Suddenly I had play in the wheel and slack in the cables. Upon lifting the cockpit floor section to access the quadrant and cable, I saw a small pile of rust under the pedestal base. I tapped the bronze sheaves and larger chunks of rust fell out like peanut brittle.

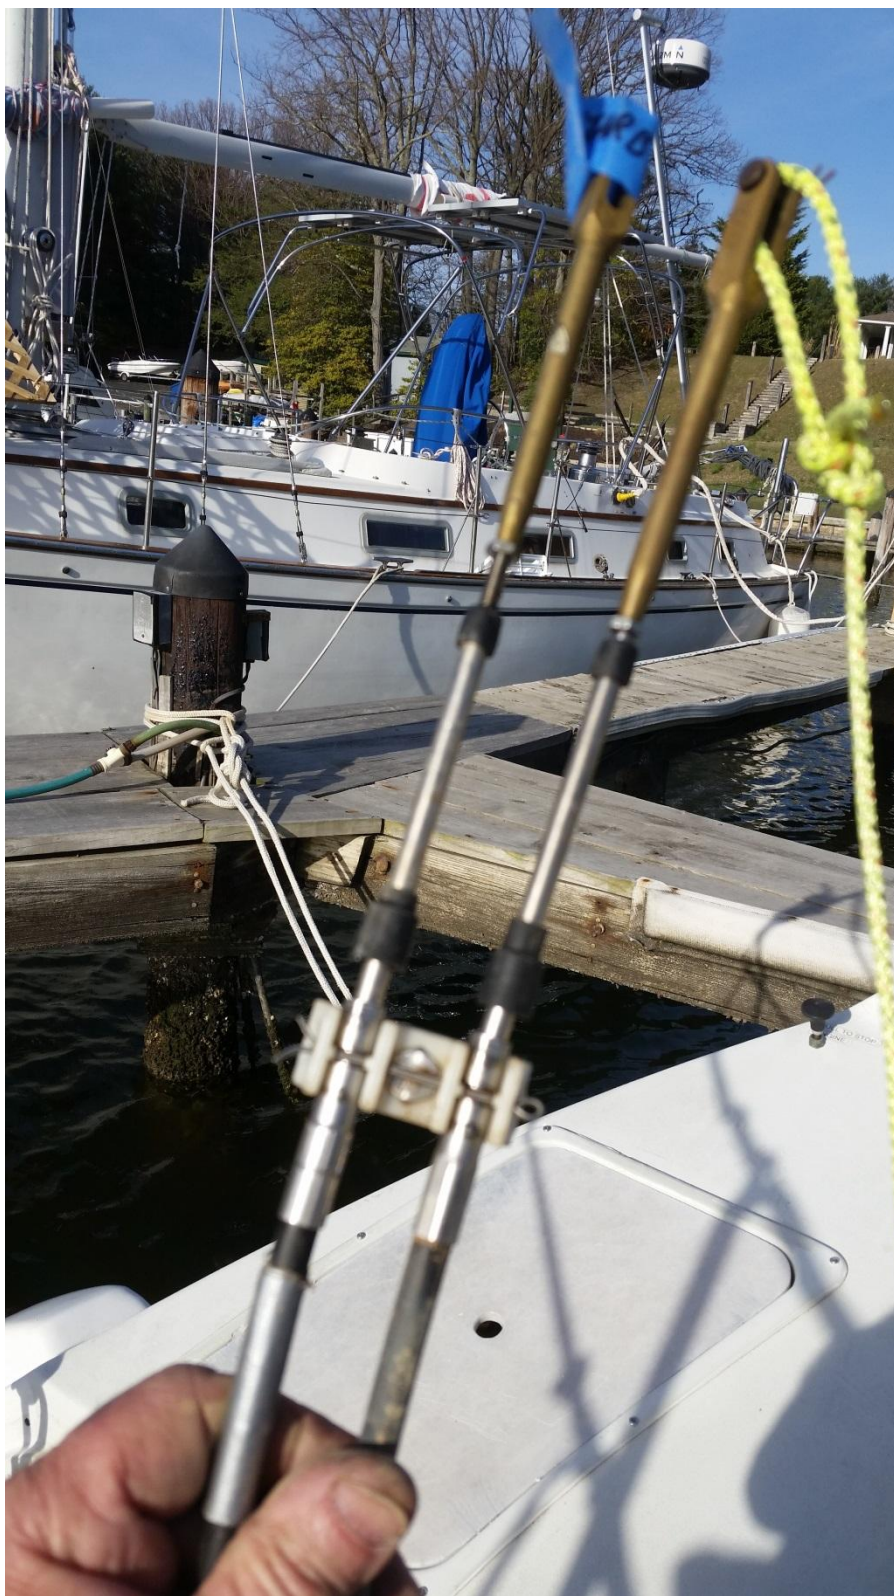
Throttle and shift cables marked.

If you attempt this project, be sure to mark the pedestal (blue tape) before disassembly and keep all parts, screws, nuts in order. For the base, I bought stainless bolts and aircraft nuts and large fender washers for a fraction of the cost of one aluminum bolt from Edson. SS is much stronger and doesn't seem to affect my compasses.

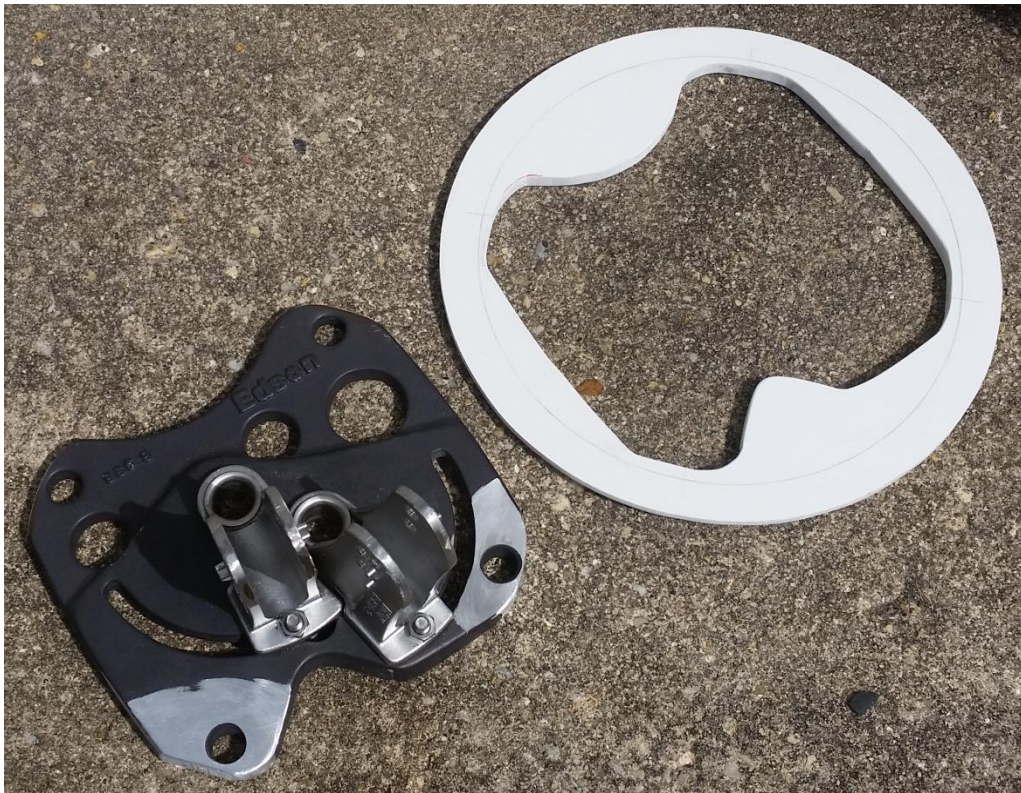
Pencil line on trim ring shows the pedestal outline.

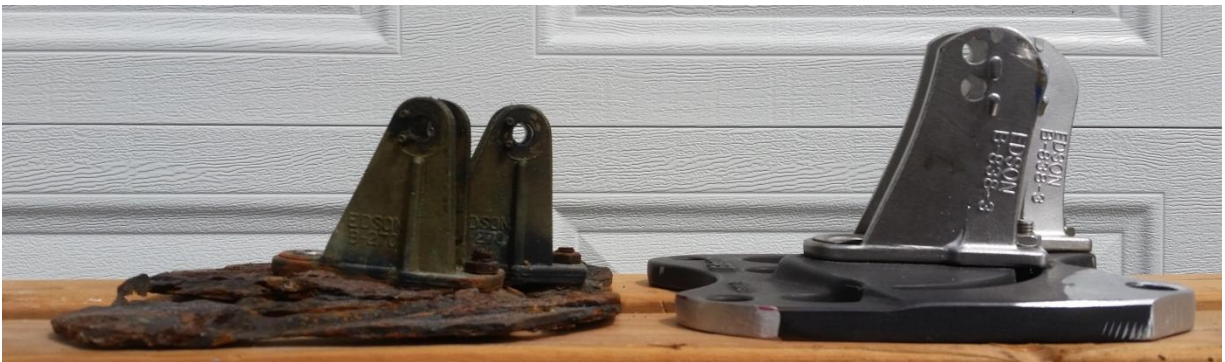
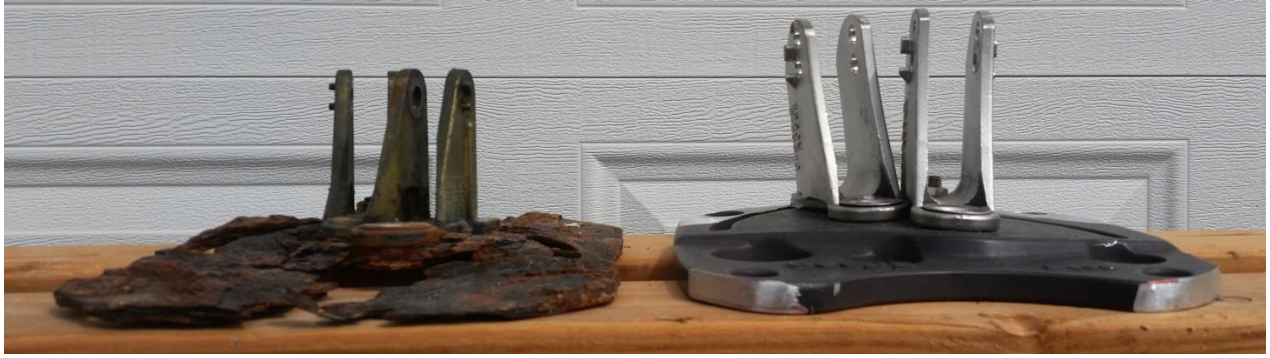
Compare holes for pulley axles: New position will be  $\frac{3}{4}$ " lower in the deck well.

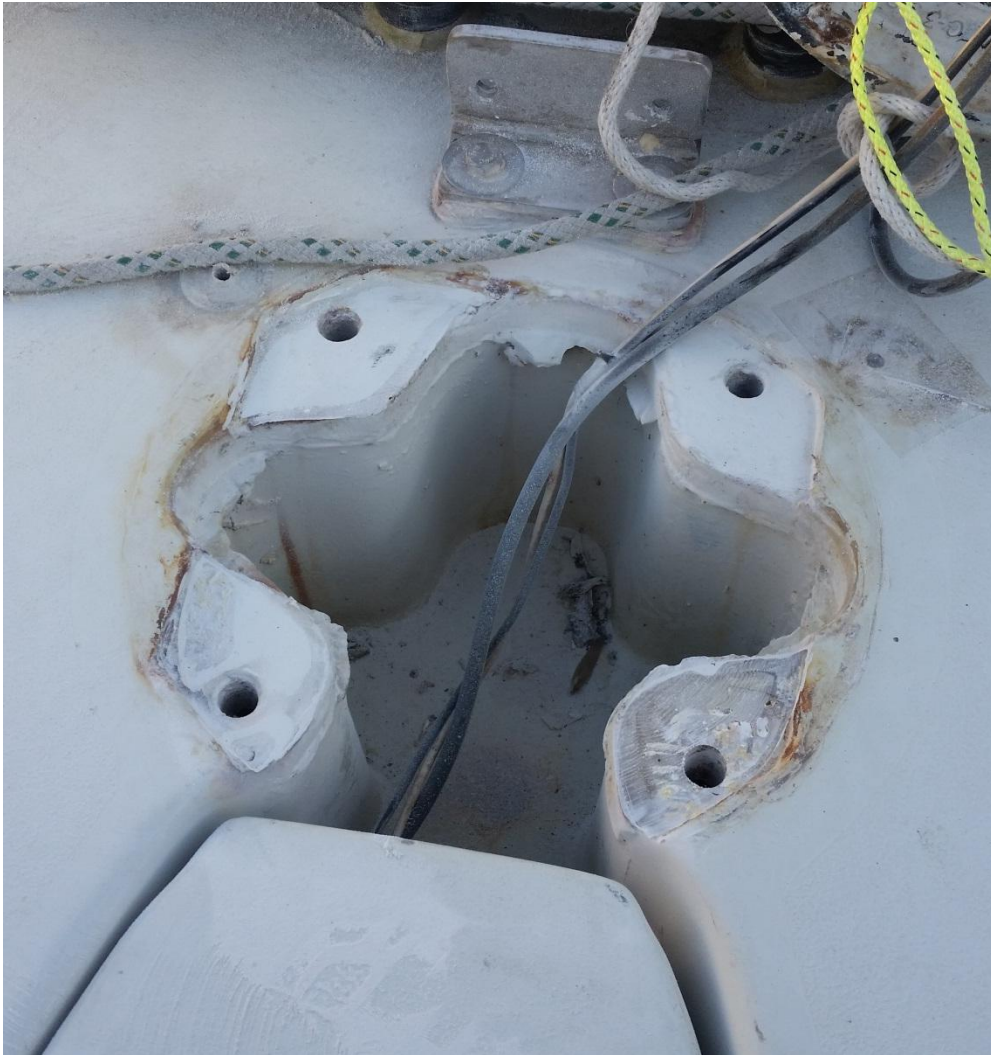
Deck Well from above.

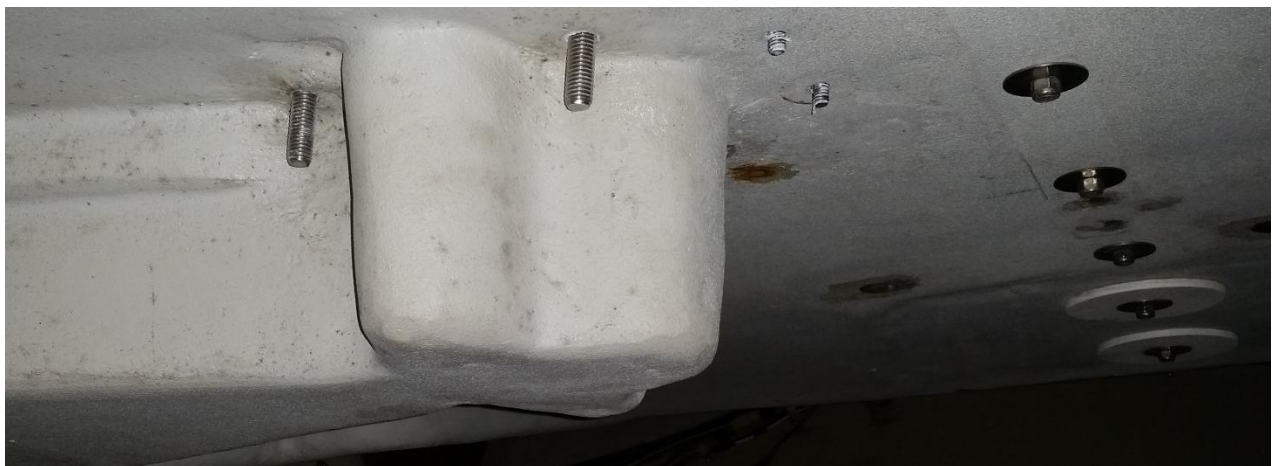
Deck Well from below.

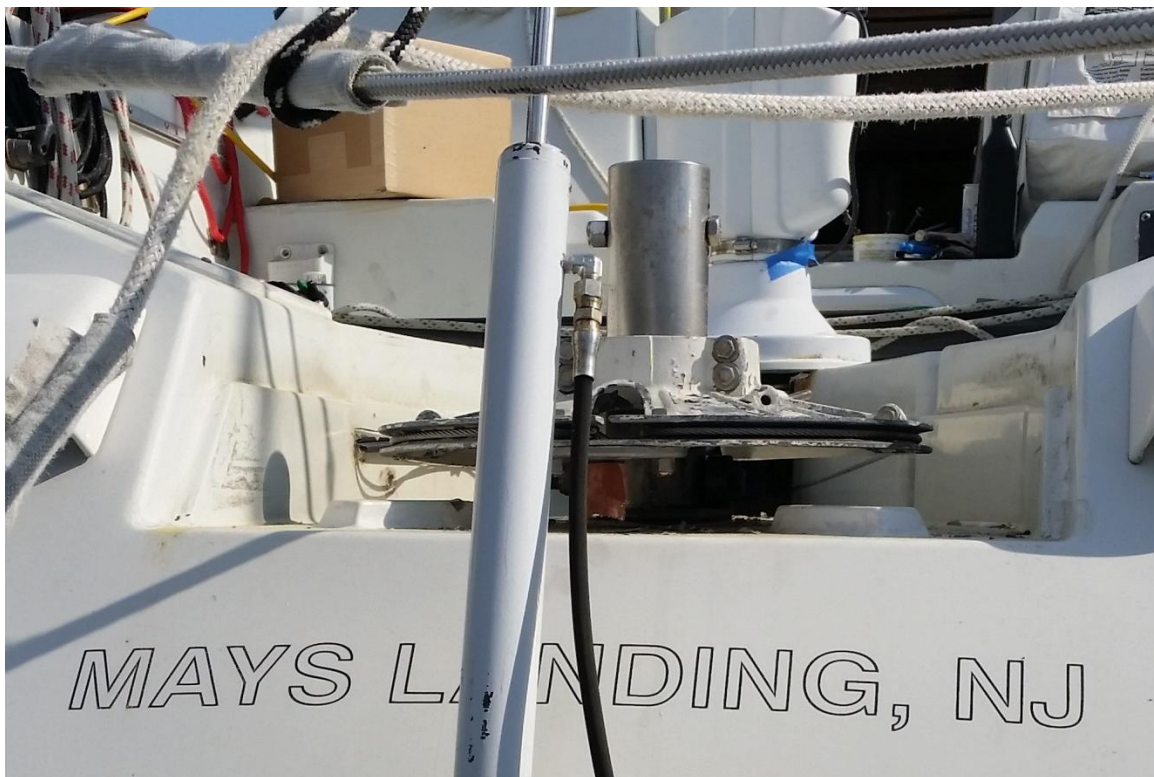
The quadrant needs to be lowered to get a fair alignment to idler pulleys.
