Forward Bulkhead replacement Wavelength 24

Project description: Replace forward bulkhead in Wavelength 24. The old bulkhead was tabbed around the entire perimeter, even the bottom. With no limber hole or opening, any water forward of the bulkhead could not drain. The bulkhead did not appear to be protected or encapsulated in any way. Over time, the bottom several inches of the bulkhead had deteriorated due to water intrusion.

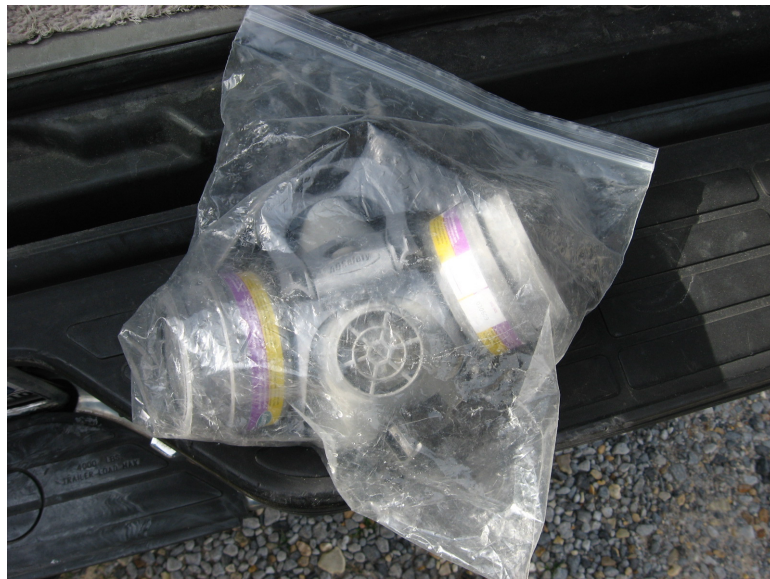
Figure 1 Dust mask protected in bag when not in use

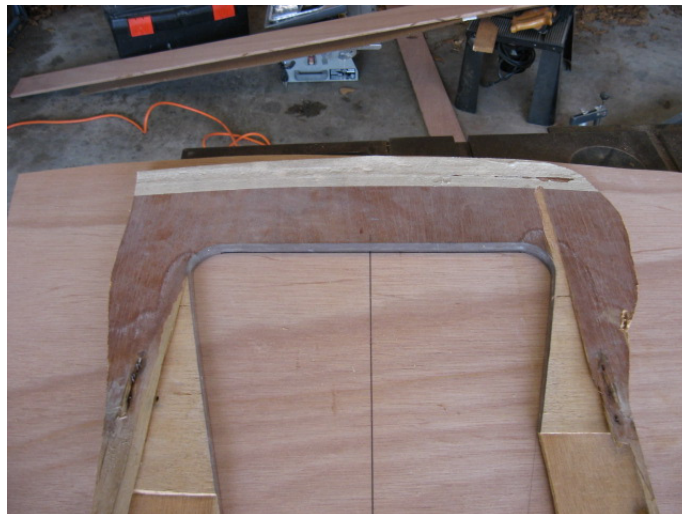
Figure 7 Old bulkhead used as pattern for anchor locker access

The center of the access in the old bulkhead was determined and marked. A centerline was marked on the new bulkhead and the pattern aligned and marked.

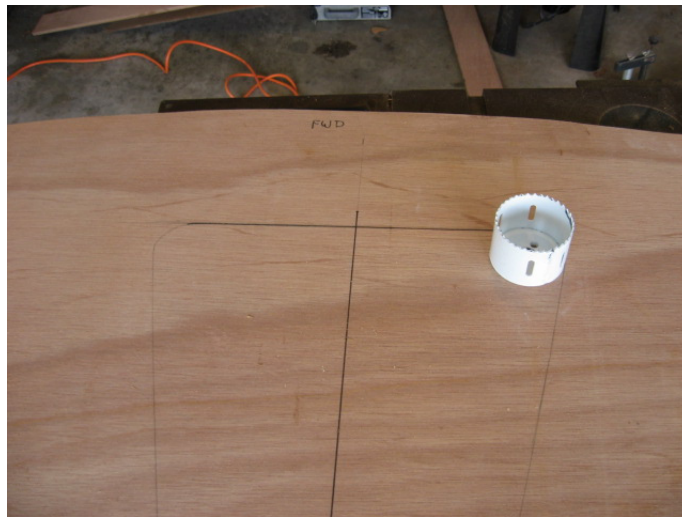
Figure 8 Hole saw placed to mark center for cut

The corners are made with a hole saw. The proper size hole saw was aligned upside down and the centering hole traced.

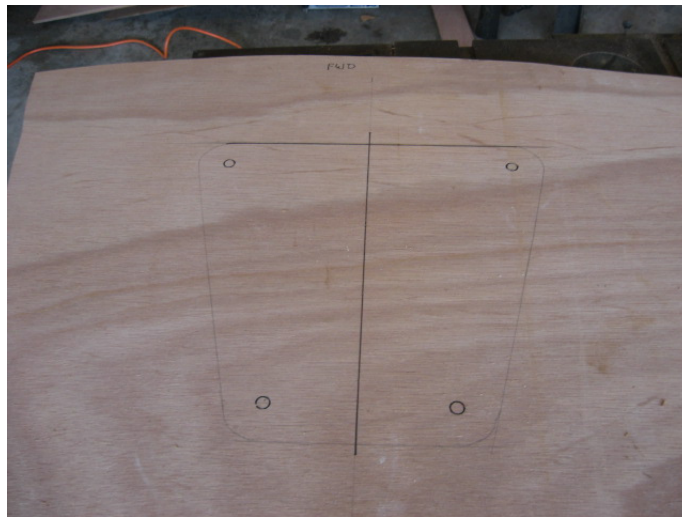
Figure 9 New bulkhead marked for drilling and cutting

Using the centering holes, the hole saw was started on one side. After partially drilling the holes, the bulkhead was flipped over and the holes were drilled completely from the other side. This process results in a clean hole. If the hole is drilled from one side only, splintering is likely when the hole saw exits the back side.

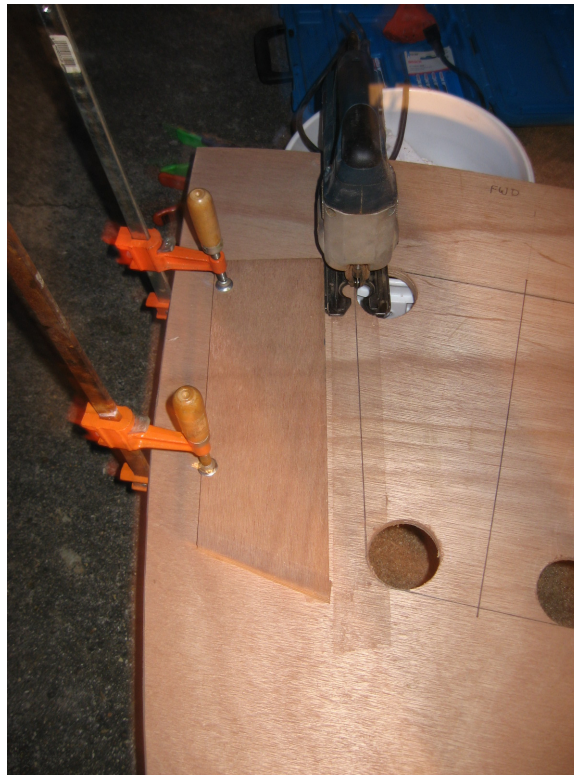
Figure 10 Connecting corner holes. Note tape on crosscut

The corner holes were connected by cutting with a jigsaw. The teeth of a jigsaw wood blade face upward and cut on the upstroke. Tape was placed on the upside to reduce splintering. A guide was clamped to the bulkhead to ensure a straight cut. Note the guide is on the outside to prevent cutting into “good” wood.

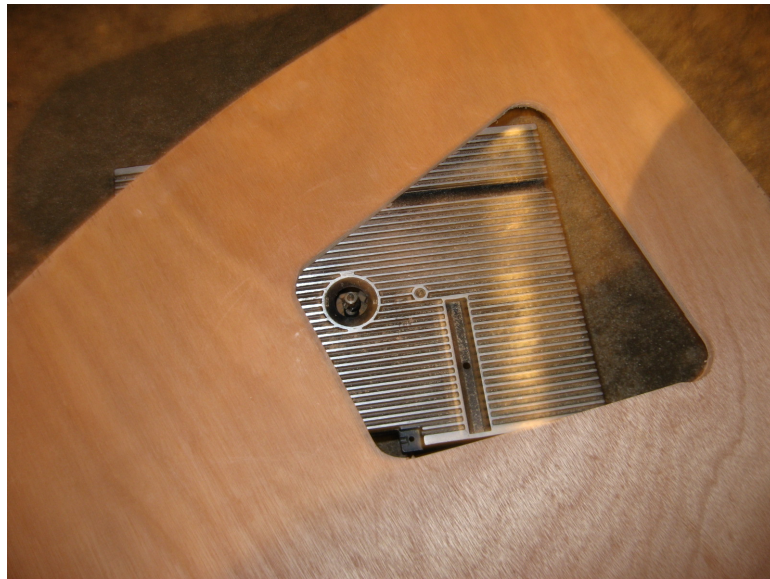
Figure 11 Router used for rounding access

The access was routed with a 1/8 inch round router bit. The edges were also beveled to conform better to the bow angle of the hull.

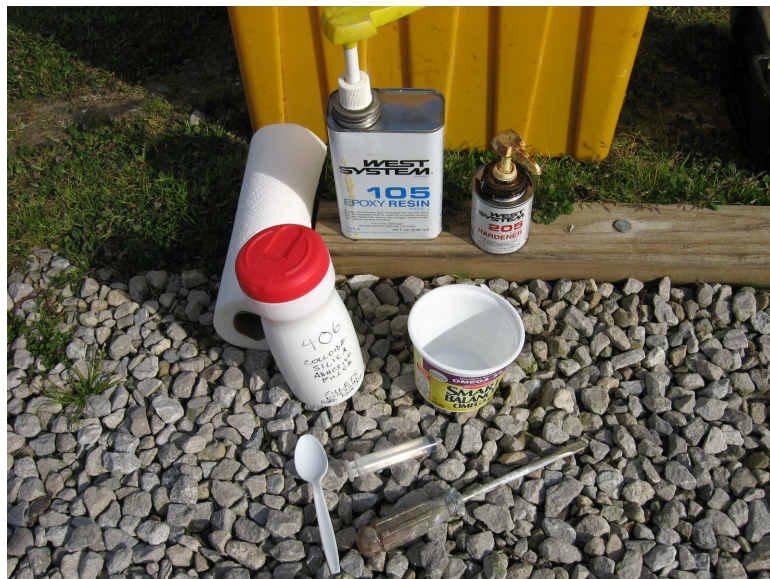
Figure 13 Materials needed for filleting

In order to eliminate a stress line on the hull, a fillet should be created at the bulkhead/hull joint. Pictured above are materials with which a fillet can be made. The epoxy resin and hardener are first thoroughly then West System 406 colloidal silica is added until the desired consistency is reached. The epoxy should be a bit stiffer than mayonnaise.

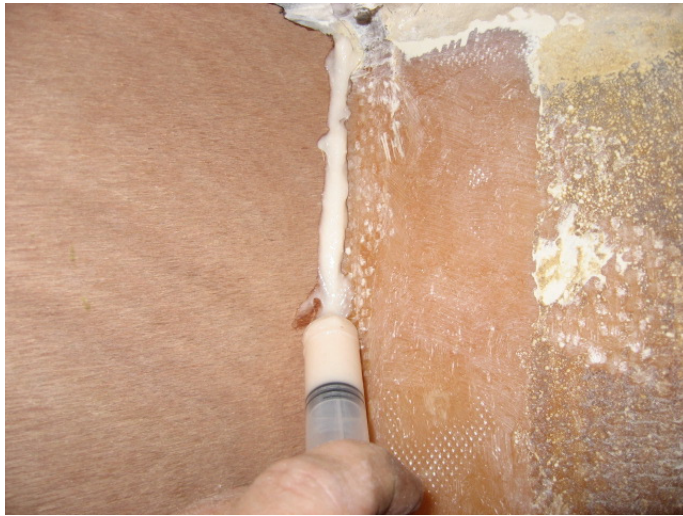
Figure 14 Thickened epoxy being applied for fillet

The thickened epoxy is applied with a syringe. Most of the tip of the syringe was cut off to extrude the thickened epoxy.

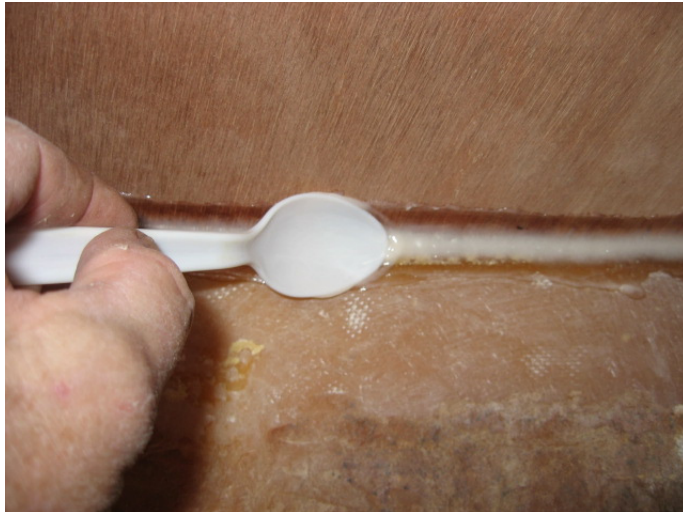
Figure 15 Spoon used to create fillet

Next, a nice round fillet is created using the back of a spoon. Excess material outside the fillet was wiped off. After curing, the fringes were sanded smooth.

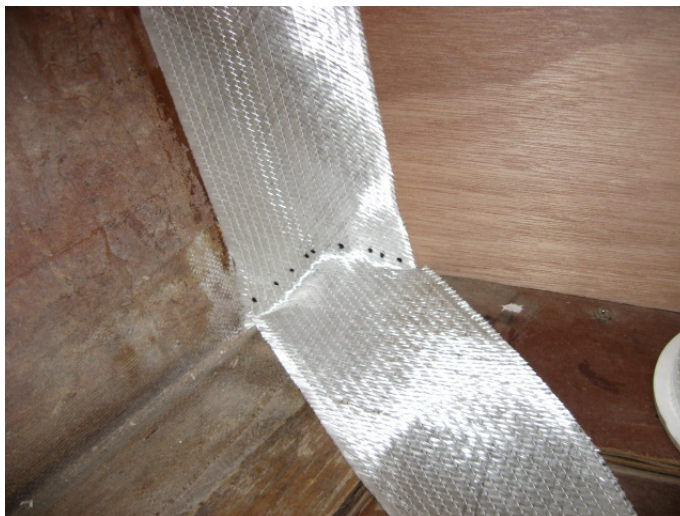
Figure 17 Tabbing tape marked for cutting

West System 727 4 inch biaxial tape was marked and cut to fit.

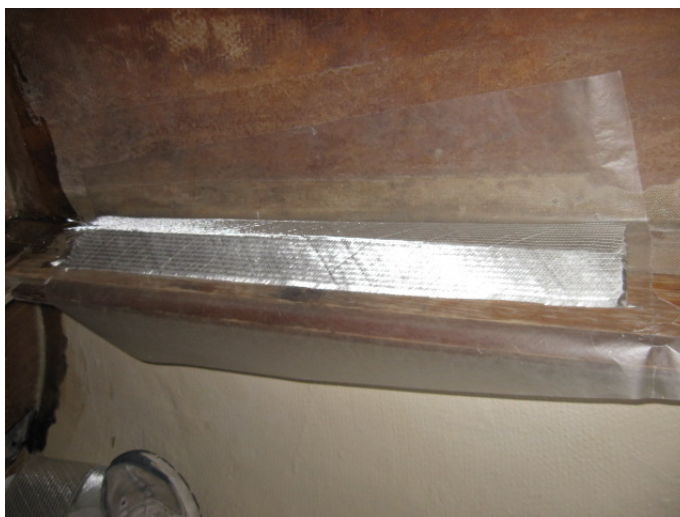
Figure 18 Tabbing tape pre-creased for corner

The biaxial tape is fairly stiff so it was pre-creased to facilitate conforming to the filleted corner. The tape was then laid on a piece of waxed paper with the bulkhead/hull side up. The tape was saturated with epoxy. The tape and waxed paper were applied to the joint and the paper carefully peeled off.

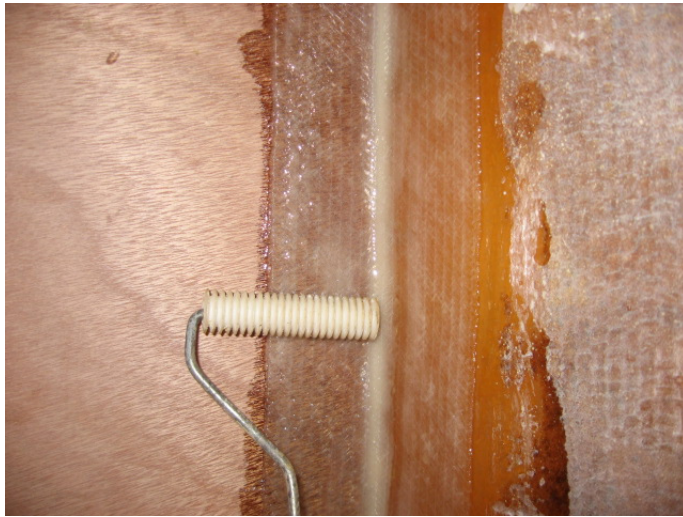
Figure 19 Laminating roller used to remove air bubbles

After the tape was positioned, more epoxy was applied with a brush. A laminating roller was used to remove any air bubbles in the lay up.

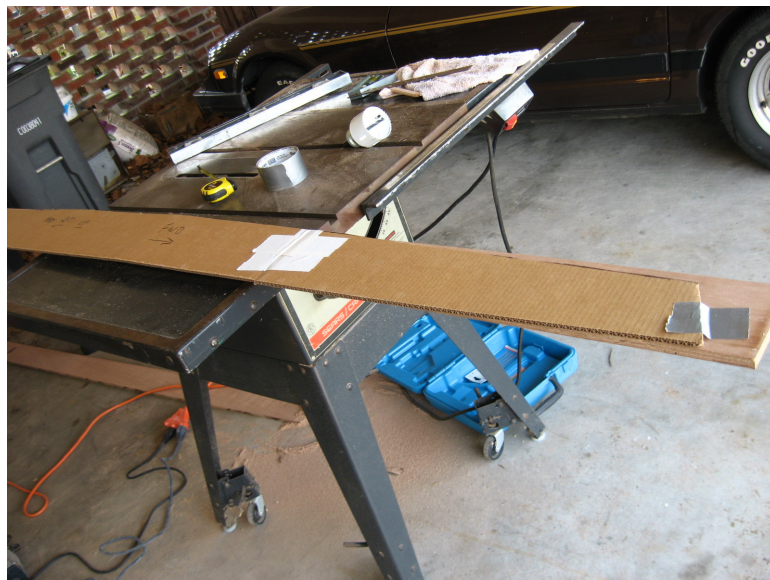
Figure 22 Cardboard pattern laid on shelf

Shelf fabrication: A cardboard pattern was made for the shelves. A strip of plywood was cut wide enough and the pattern taped to it. A jigsaw was used to make the curved cut. To make the straight end cuts, a guide was clamped to the shelves.

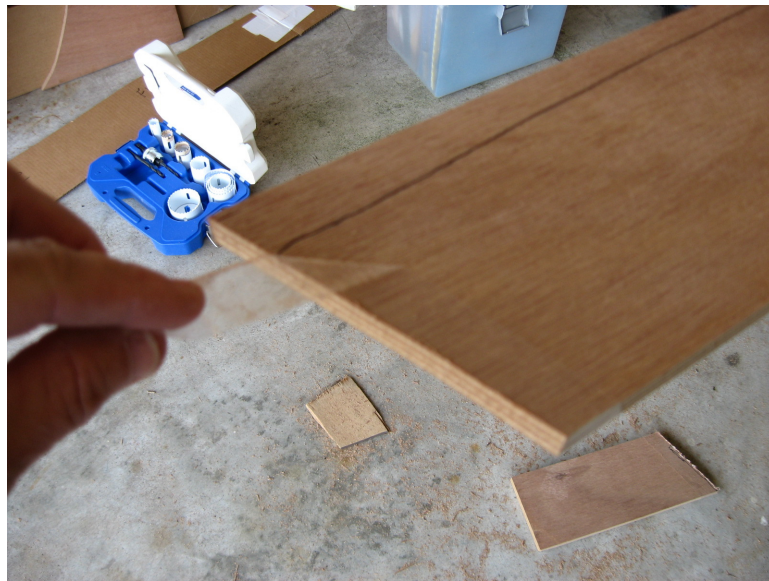
Figure 23 Removal of tape

As with the bulkhead, any crosscutting was taped prior to cutting to reduce the potential for splintering. The tape should be removed by pulling at angle towards the cut edge.

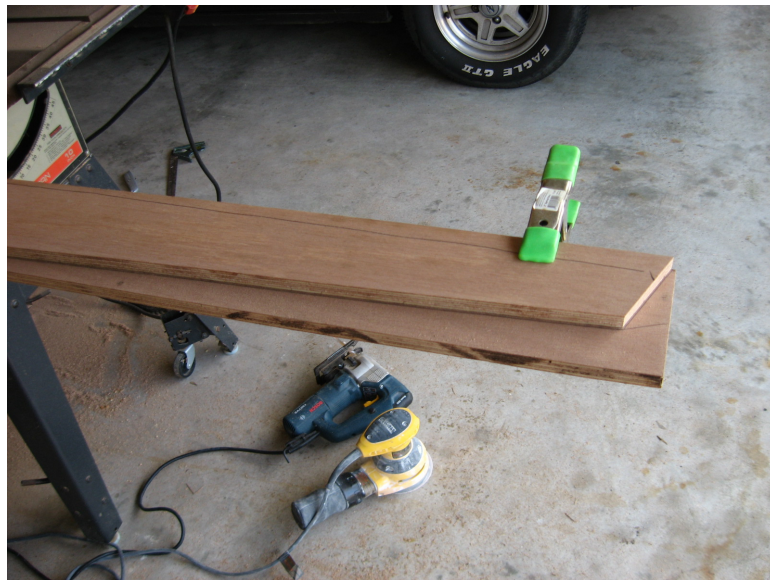
Figure 24 One shelf used as pattern for second shelf

The shelves were virtually identical, just mirror image so the first shelf was used as the pattern for the second.

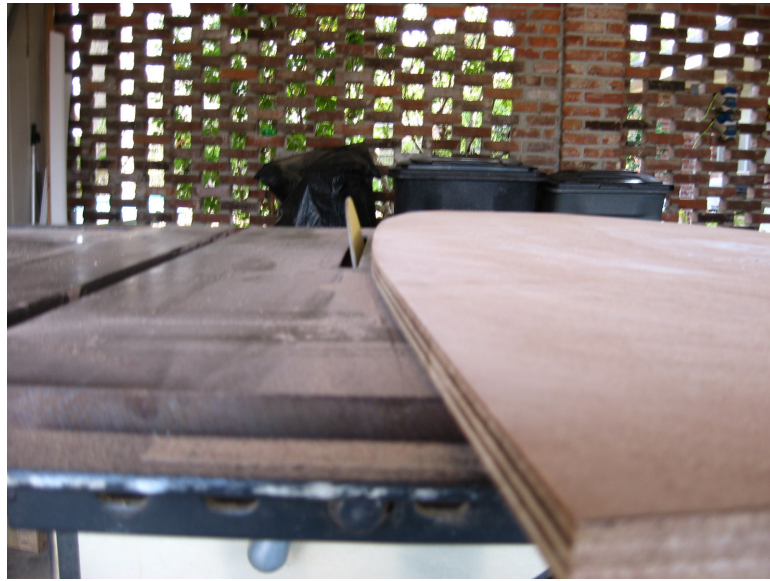
Figure 25 Table saw sanding disc set to make angle for hull abutment

To more closely conform to the inward sloping angle of the hull, the outside of each shelf was beveled.

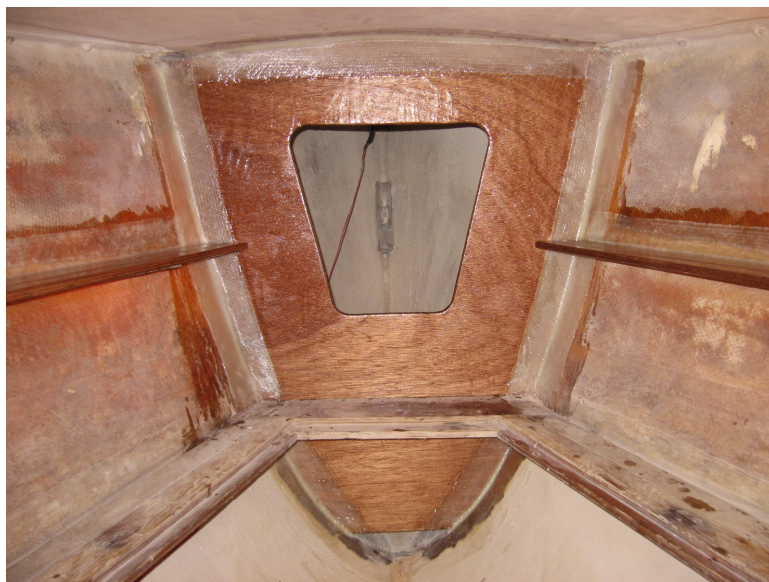
Figure 28 Installed shelf (minus cleats)
